# 1

## Introduction

# GORDON CREEK

## Watershed Management Plan

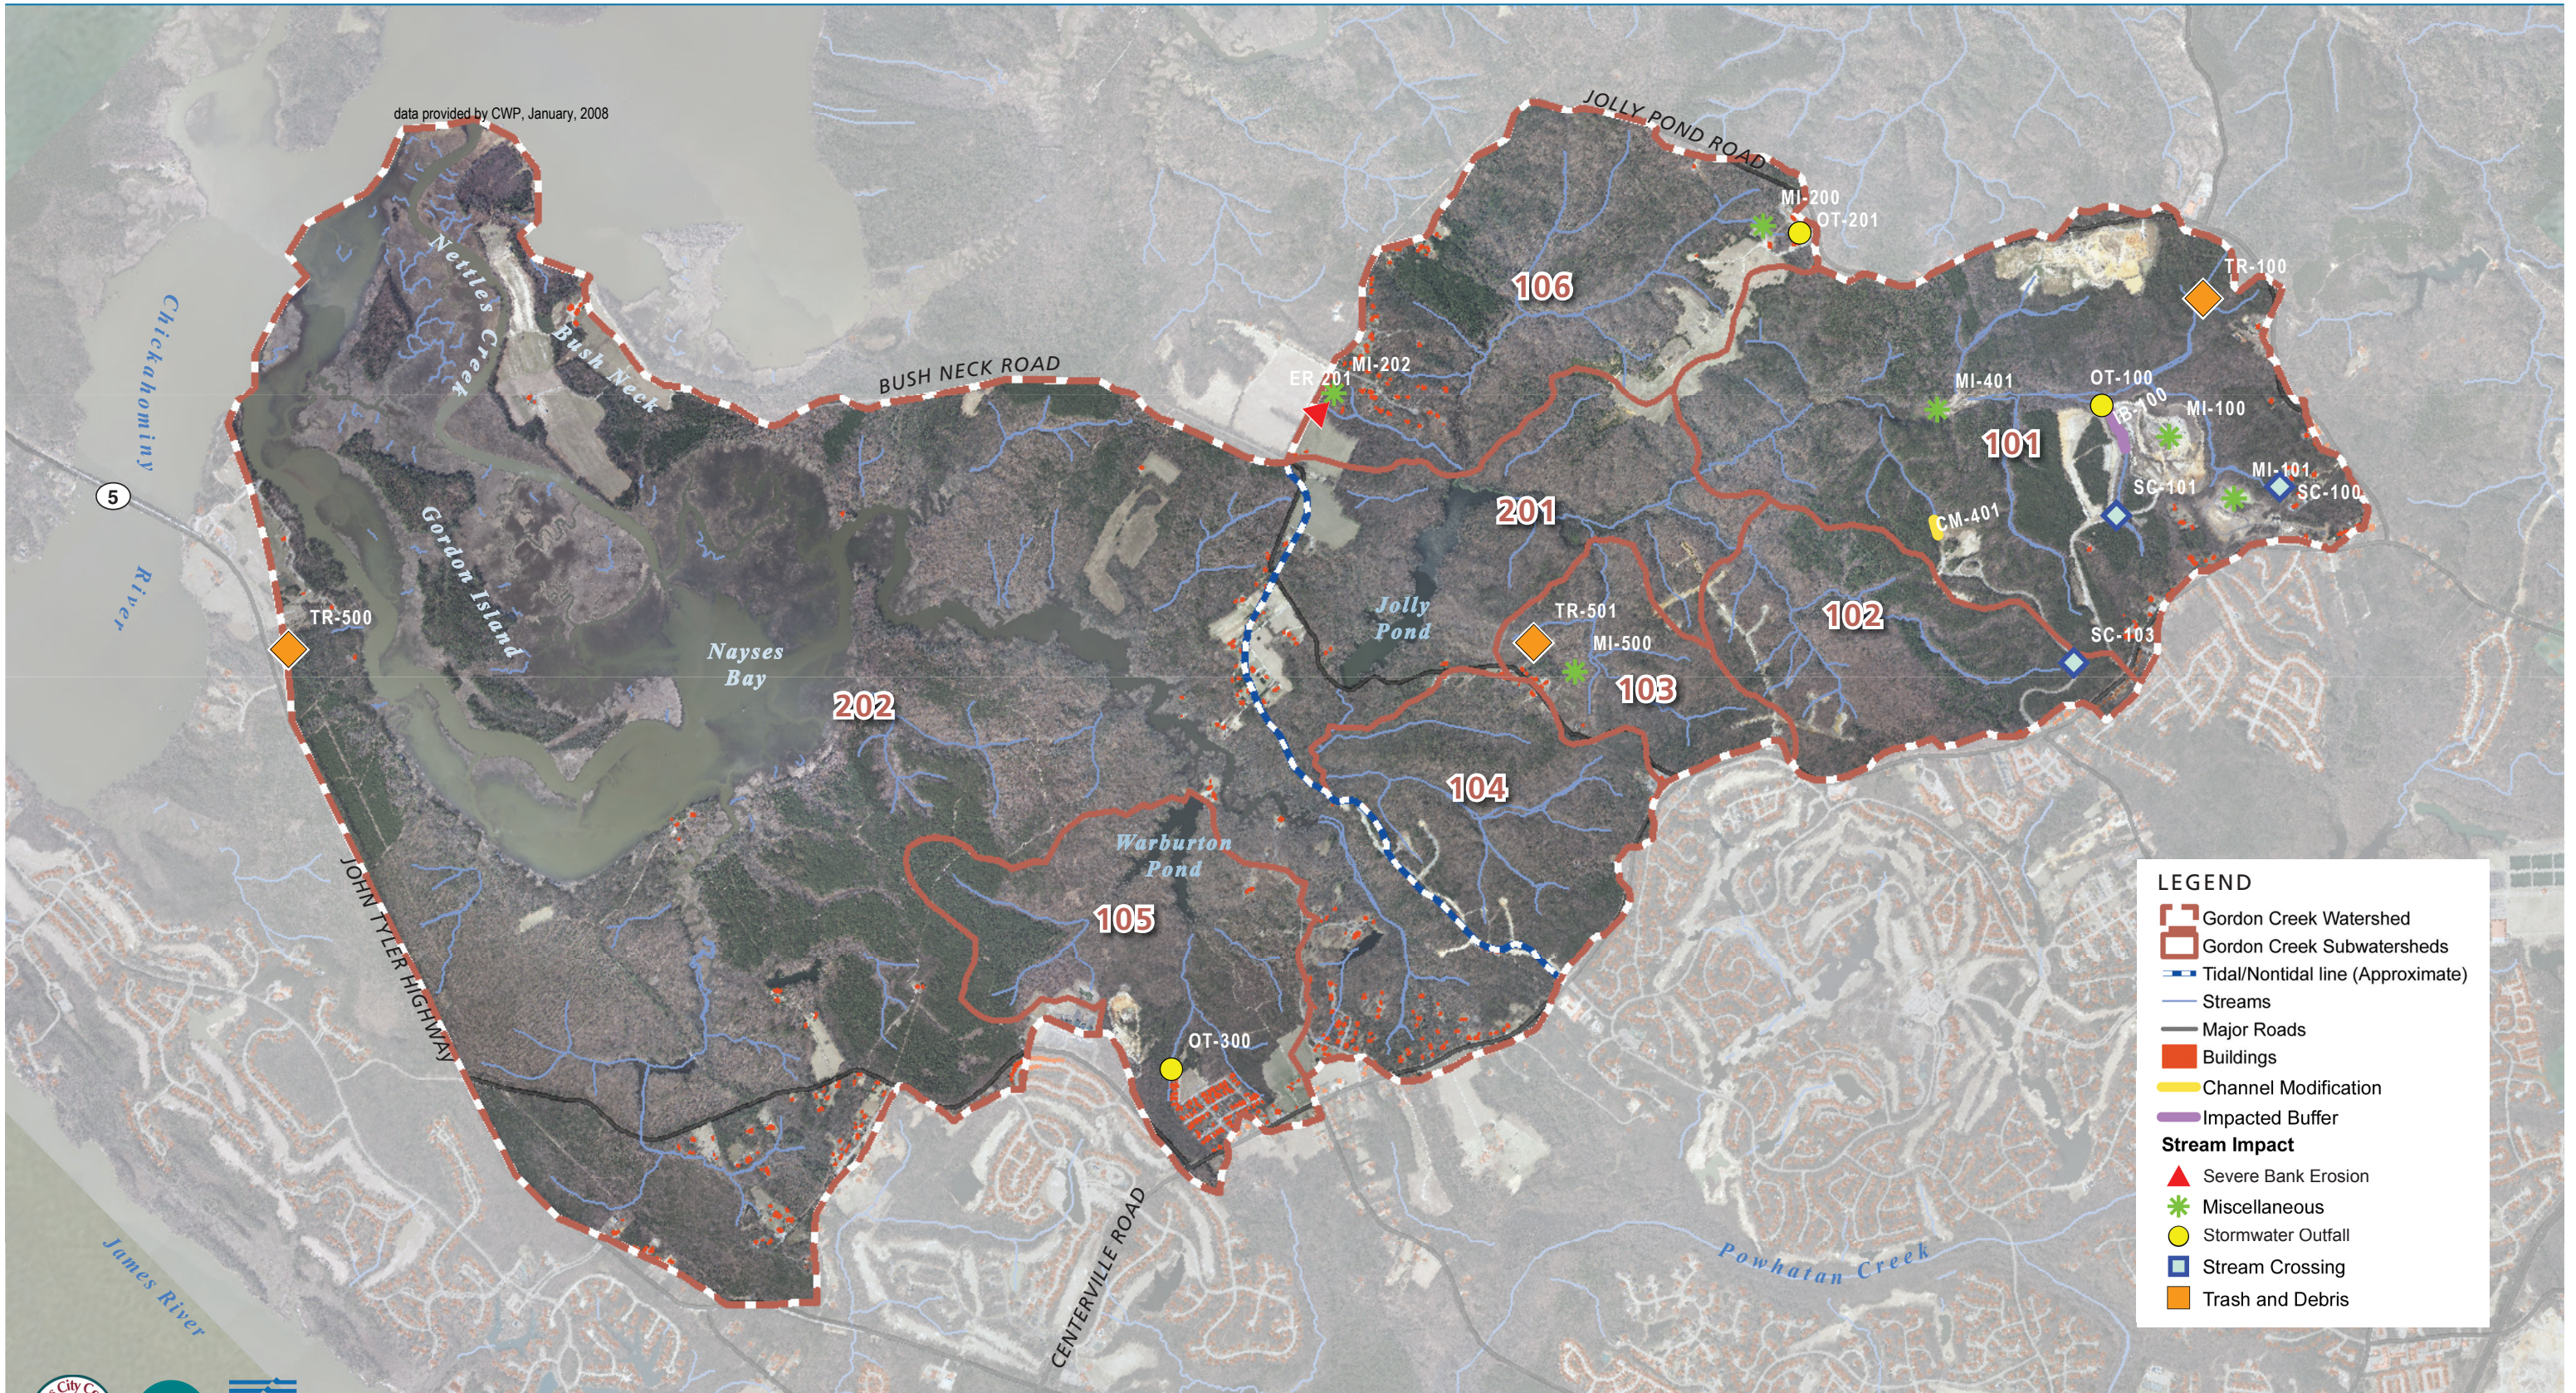
Figure 1-4

Gordon Creek Watershed  
Stream Impacts

Each of the stream impact areas identified by the CWP is included in Table 1-1 along with their description and the prescribed action. Their specific locations are depicted on Figure 1-4.

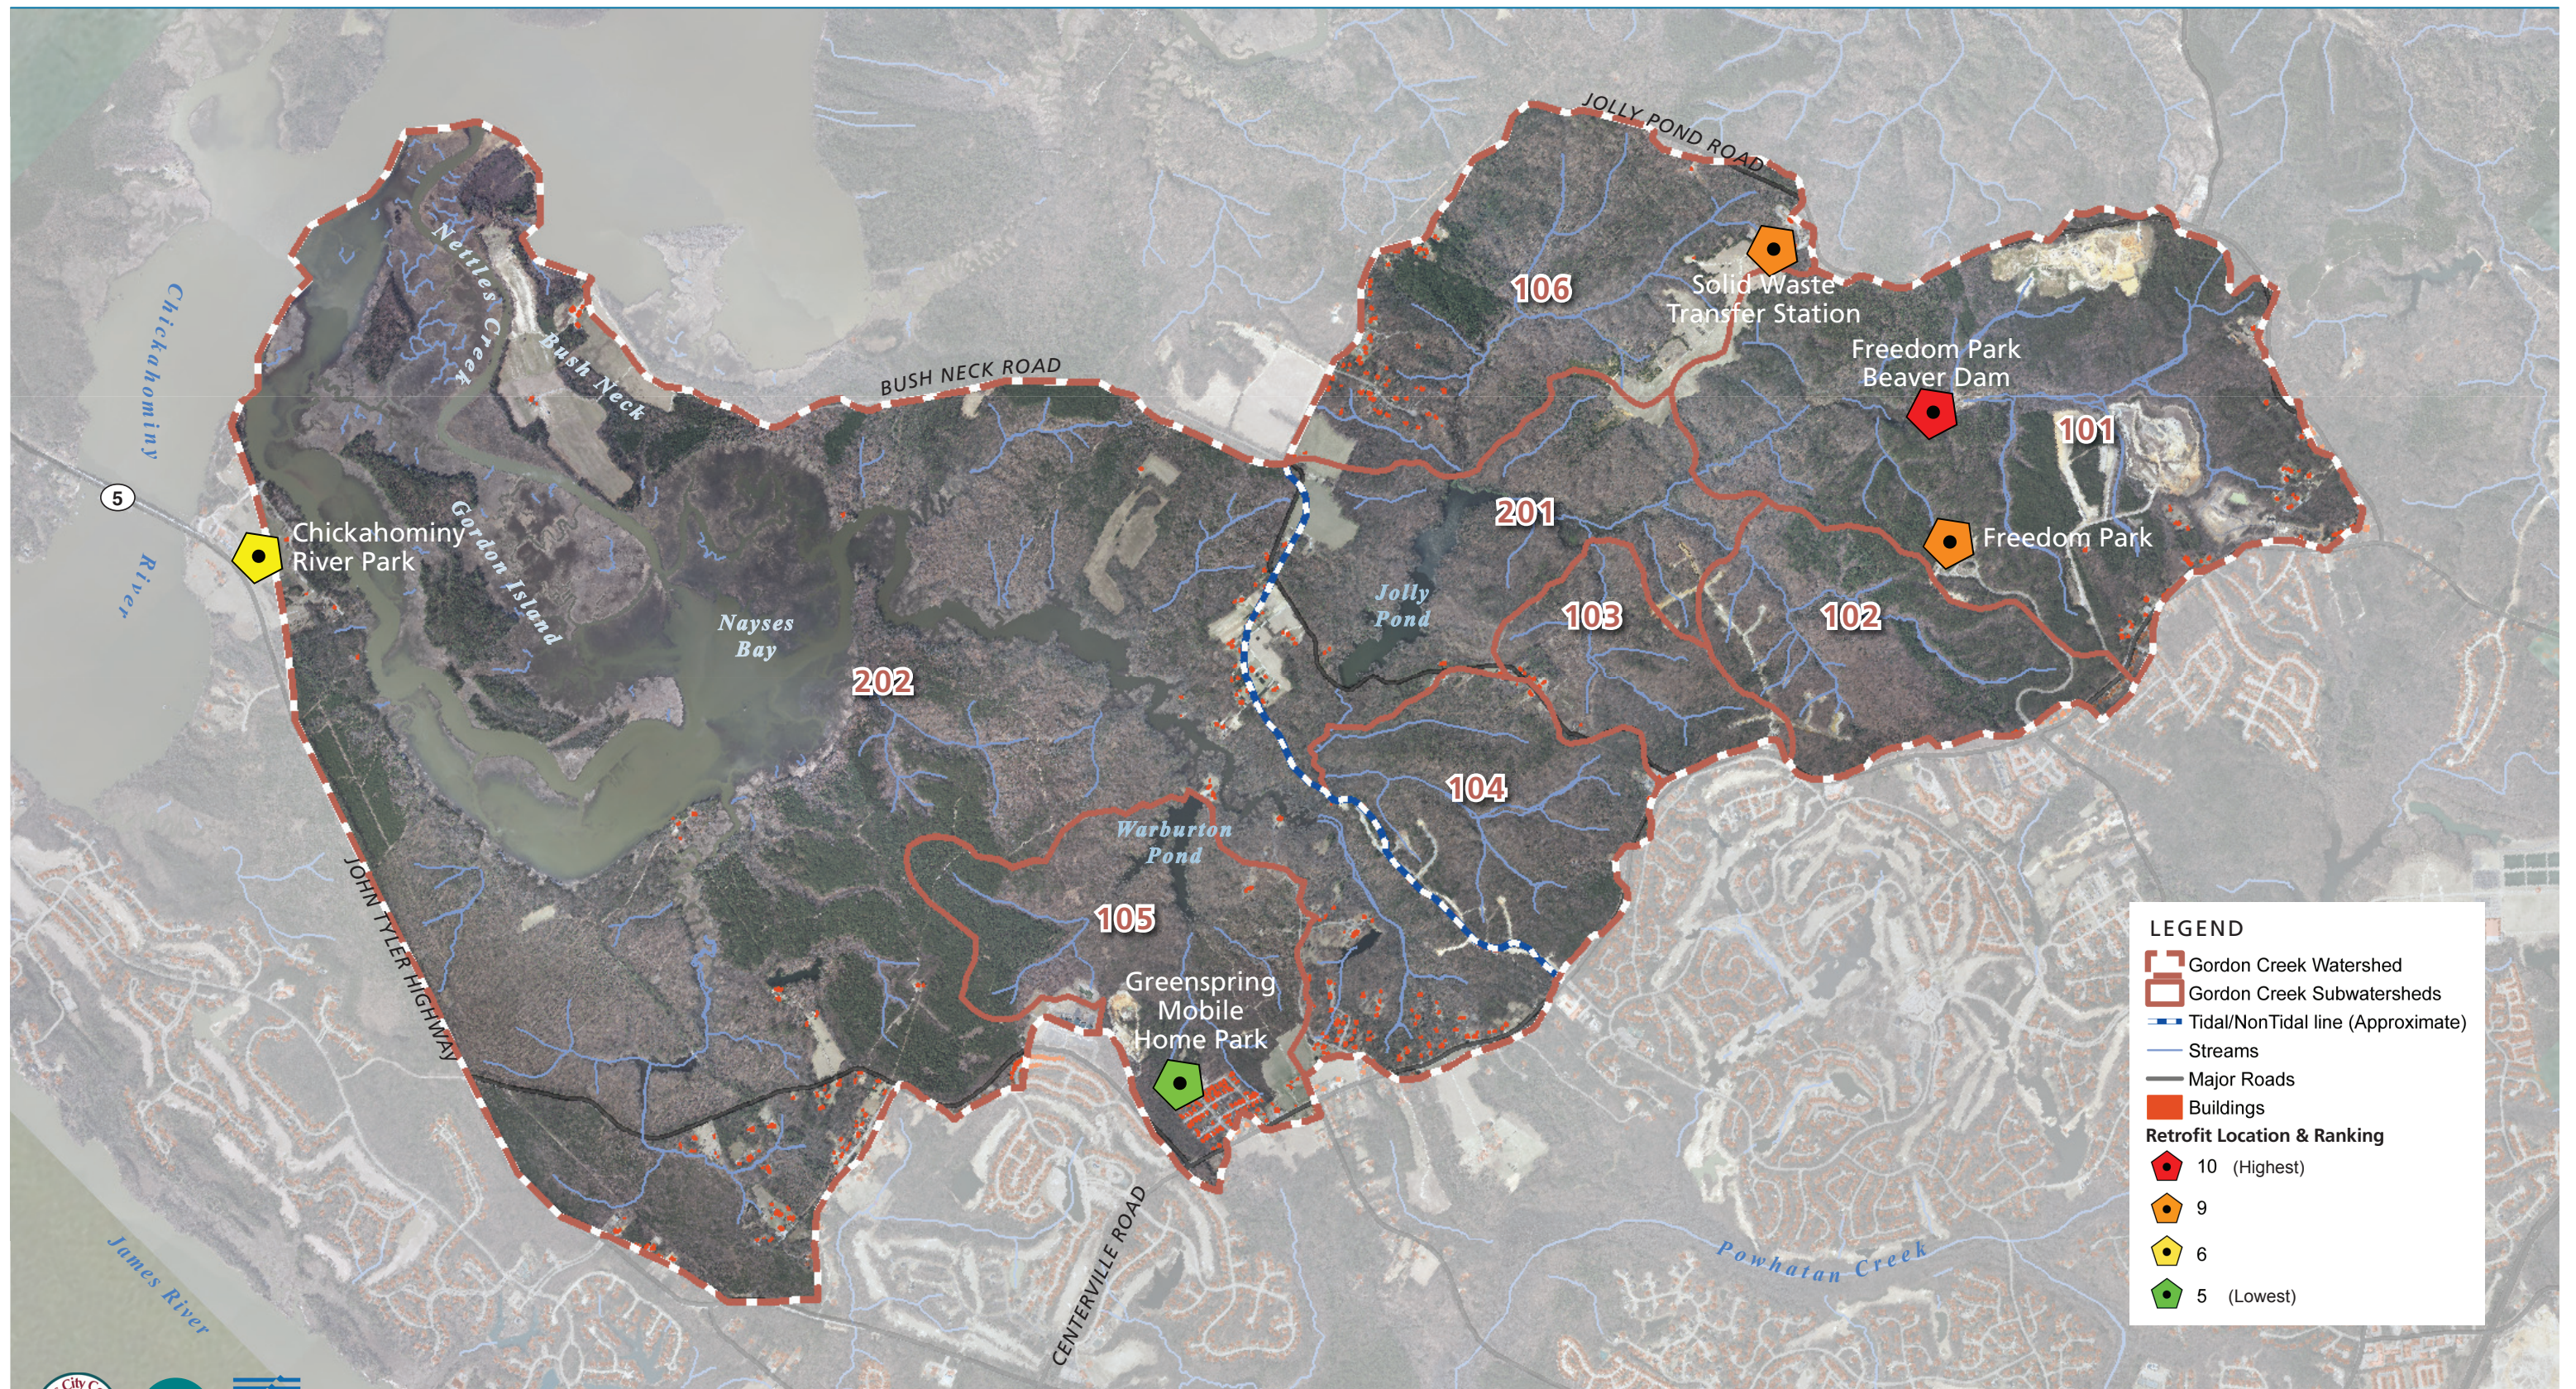
Figure 1-6

**Gordon Creek Watershed  
Stormwater Retrofit Ranking**

The five remaining stormwater retrofit opportunities are depicted in Figure 1-6, color-coded in terms of their priority.
